DEVELOPMENT OF A MONITORING PROTOCOL FOR BIOENGINEERED
SEDIMENT MITIGATION RELATED TO STREAM ADJACENT BANK FAILURES
ON FOURMILE AND SHOLES CREEKS IN THE MATTOLE RIVER WATERSHED

A Thesis

The Faculty of Humboldt State University

May, 2006

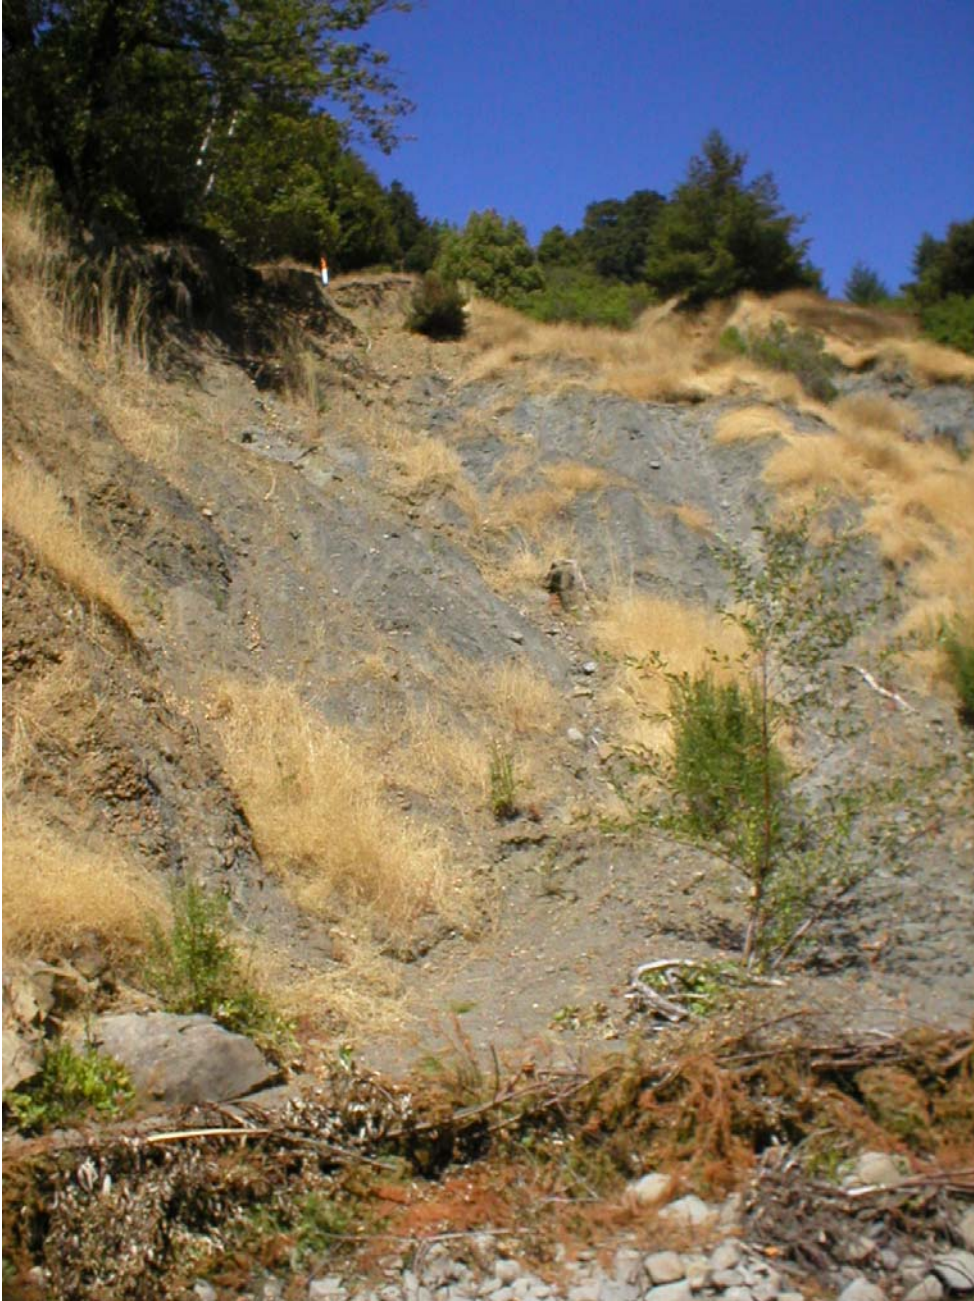
Figure 4. Willow fence at the bottom of Site 27, July 26, 2004.

In order to mitigate erosion from stream adjacent bank failures and landslides, the Mattole Restoration Council treated sites by constructing bioengineered willow fences along the base of each slide. Fences were three to five meters in length and 0.5 to 1.0 meters tall. Fences were held together with heavy twine and spiked with willow cuttings. The willow cuttings were expected to sprout and grow over time, helping to stabilize the toe of the failing bank, provide filtration for sediment generated from above, and deflect the flowing stream away from the toe of the slope. The fences were constructed of tree branch material found near the treatment site. The main frames of the fences are no larger than ten centimeters in diameter, with much smaller branches comprising the “slats” of the fence.

Significant physical change was noted for treatment structures on both Sites 27 and 26. Both sites consist of large, active slides with significant gully action. Between 2004 and 2005, willow fence structures on both sites were completely backfilled with soil from the landslides above. Despite backfilling, the willow fences appeared completely intact and the willows sprigs were well sprouted. These physical site observations indicate that fences did result in a positive benefit to Fourmile Creek by withholding sediment from entering the stream.

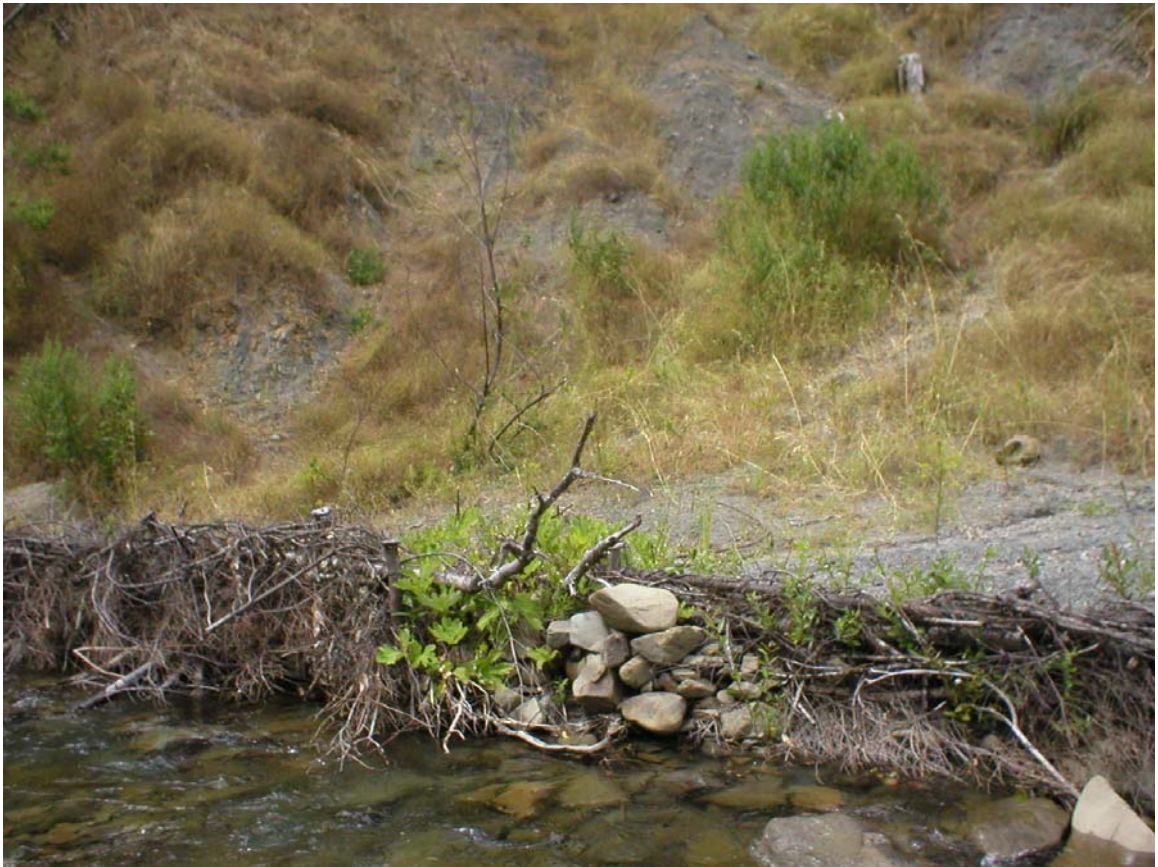
Figure 5. Willow fence at Site 27, nearly one year after installation with willow sprouts, June 28, 2005.

In general, willow sprig survivability in the fence structures was poor to moderate with several exceptions, such as with Sites 26 and 27, noted previously. This can be remedied in the future by supplying the remaining fence structures with additional willow sprigs to encourage sprouting and riparian development.

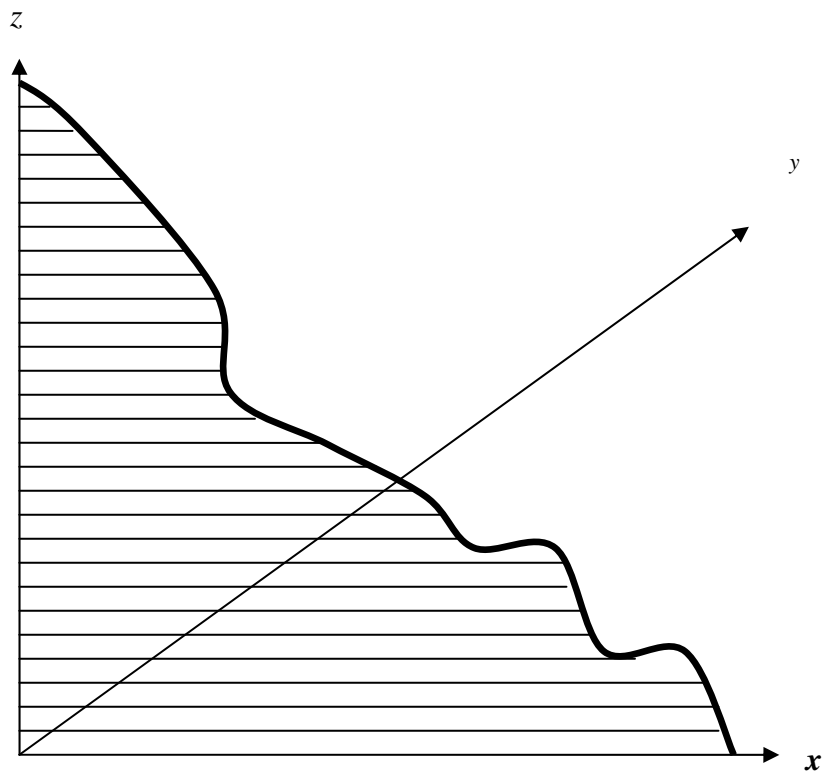
Figure 6. Calculating hillslope volume in ESRI ArcMap 9.1 based on arbitrary surface plains created by the software.

The relationship between hillslope soil volume and slope is largely an artifact of ESRI ArcMap 9.1's calculation of hillslope volume (Figure 6.) This study found that landslides with larger hillslope volumes were less steep than landslides with smaller hillslope volumes. Landslides with larger hillslope volumes, shown in blue, are less steep than landslides with smaller volumes, shown in red (Figure 14).

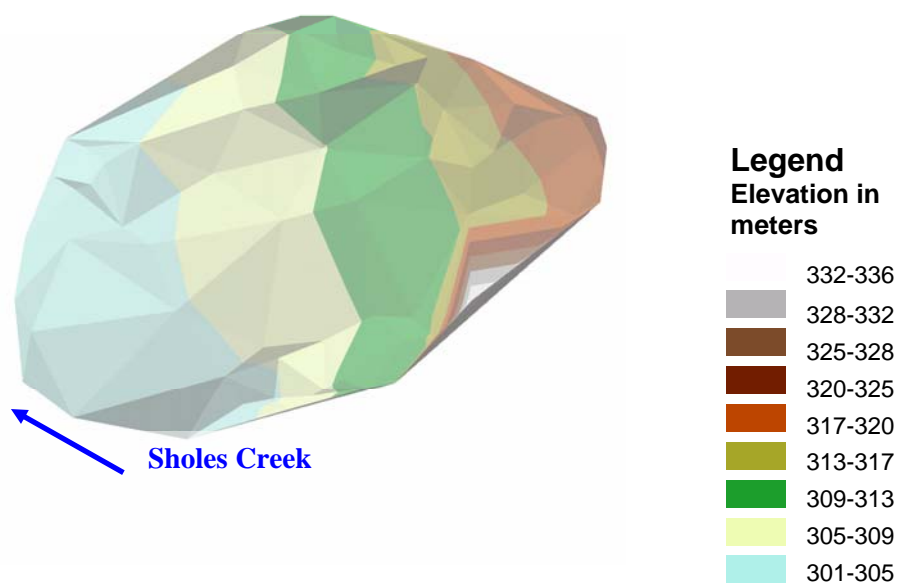
Figure 7. 3-D model of Site 37 created in ESRI ArcMap 9.1 using 2004 baseline data with a 305 meter base elevation.

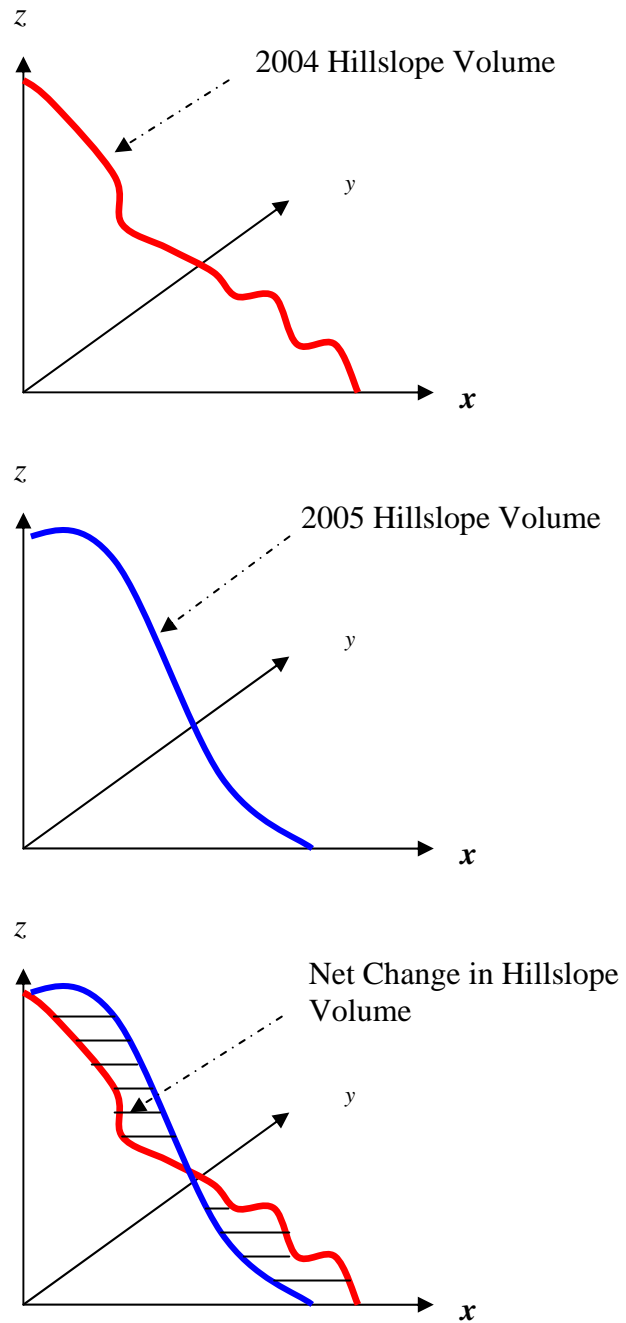
Figure 8. Timestep calculation of net change of hillslope soil volume.

The Microsoft Excel spreadsheets were imported into Earth System Research Institute (ESRI) ArcMap 9.1 (ESRI, 380 New York Street, Redlands, California, www.esri.com) under the “Add x,y data” function. One spreadsheet contained 2004 data and the second spreadsheet contained 2005 data. The data for each year was converted into a separate TIN file using the 3-D Analysis extension. Once a TIN file had been created for each year, it was possible to obtain calculated values for height, width, and slope. The Cut-Fill tool in the 3-D Analysis toolbar was used to determine the loss and gain of soil hillslope volume throughout the site. ESRI ArcMap 9.1 calculated hillslope volume based on the lowest coordinate points provided (Figure 6). This calculation was based on the creation of an arbitrary plain and not the actual failure plain under the soil surface. A 3-D image of data collected from Site 37 in 2004 is shown in Figure 7. This figure is representative of the 3-D models used to determine net gain or net loss of soil from all twenty hillslopes. One model was created for 2004 data a second model for 2005 data. The models were overlaid, as shown in the timestep process in Figure 8.

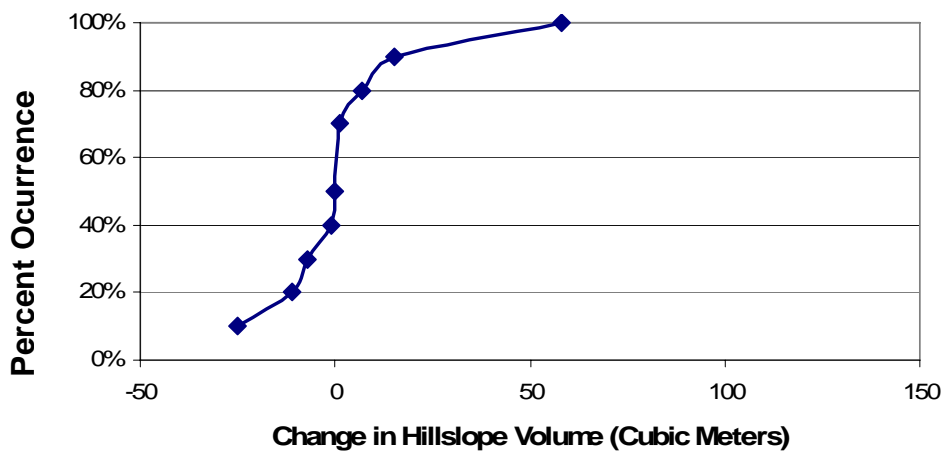
Figure 9. Cumulative frequency distribution for change in hillslope volume for control sites.

Cumulative frequency distributions (Figures 9, 10), of first year change in hillslope volumes for control and treated sites indicate the majority of landslides in both

categories experienced a net gain or net loss of hillslope soil volume between -50 and 25 cubic meters. There were several treated site that experienced a significantly larger loss in hillslope soil volume (Figure 10) relative to the change in hillslope volume experienced by control sites.

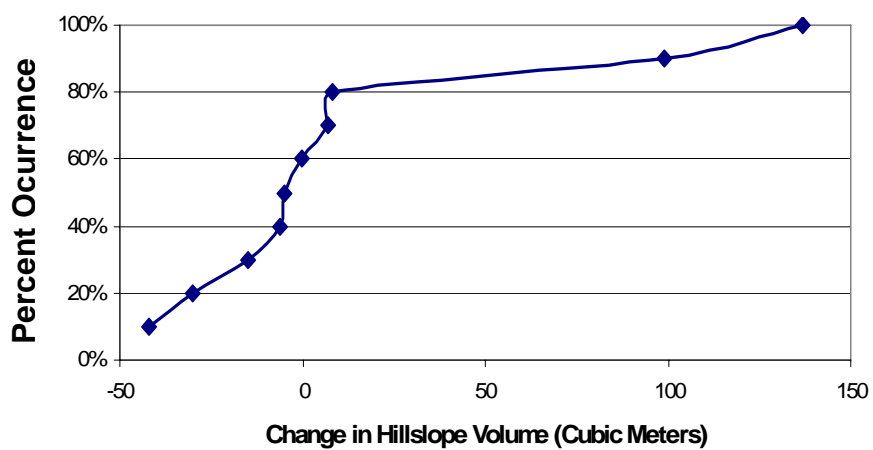
Figure 10. Cumulative frequency distribution for change in hillslope volume for treated sites.

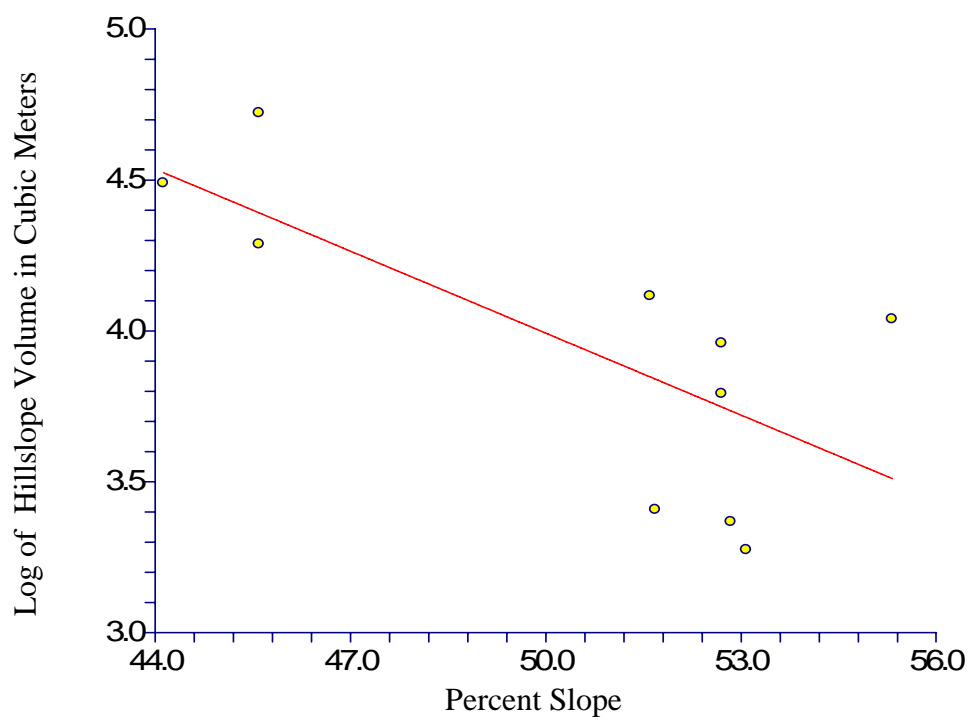
Figure 11. Linear regression plot section results, 2004 control site data, R-Squared of 0.52.

A linear regression analyzing the relationship between landslide slope and hillslope volume was done for both 2004 and 2005 control and treated site data. A representative linear regression plot section is shown in Figure 11. Data was log transformed in order to improve the large range in standard deviations that otherwise exist.

With linear regressions, an R-Squared value of zero represents no linear relationship. An R-Squared value of one represents a perfect linear relationship. The linear regression illustrated in Figure 9 of 2004 control site data had an R-Squared value of 0.52, while 2005 control site data in 2005 yielded an R-Squared value of 0.60. Similarly, the linear regression of 2004 treated site data had an R-Squared value of 0.58. The corresponding linear regression for 2005 treated site data resulted in an R-Squared value of 0.68. All four R-Squared values indicate that there is a weak relationship

between slope and hillslope volume for landslides in this study. Fifty-two to 68 percent of the observed variation in hillslope volume is explained by the variation in percentage slope for the linear regressions.

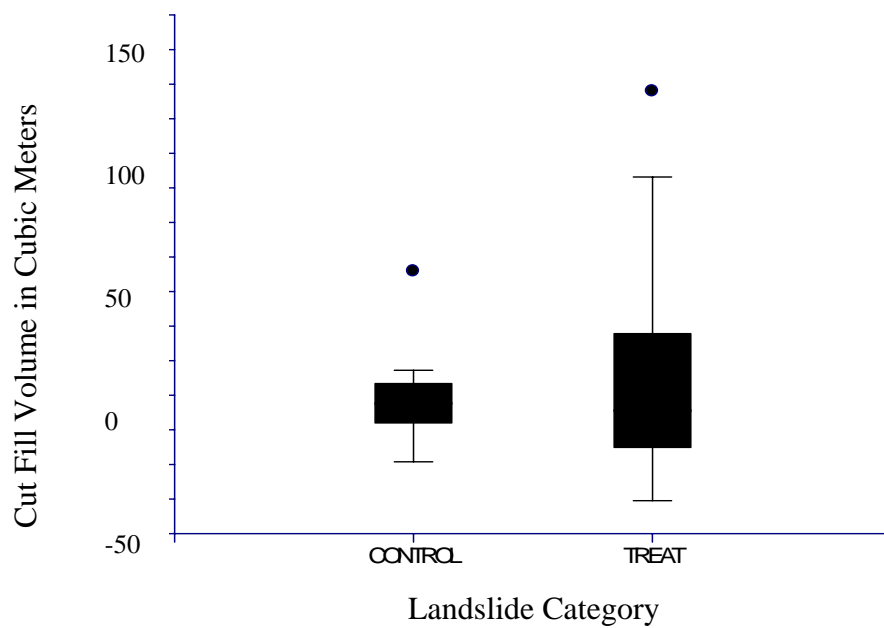
The box plot in Figure 12 depicts the difference in net gain or net loss of soil volume from the landslide between 2004 and 2005. Figure 12 indicates that treated sites had a much larger range of net loss or net gain of hillslope soil volumes than control sites.

Figure 12. Box plot of net gain or net loss of hillslope soil volume from control and treated landslides, 2004 through 2005.

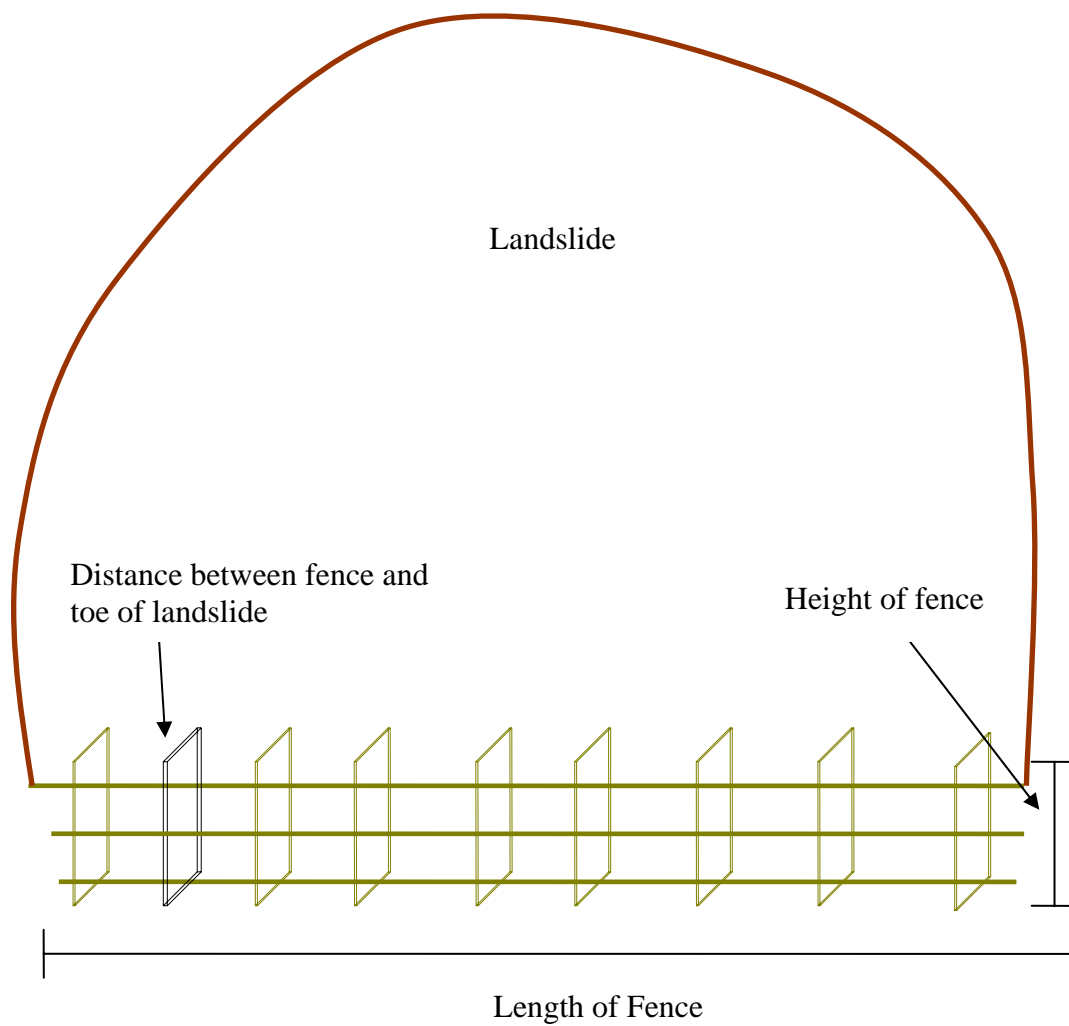
Figure 13. Estimating willow fence holding capacity.

sediment but gained 137 cubic meters of sediment overall—a ratio of 1:34. The soil volume the willow fences were able to retain from entering the stream at their maximum capacity was significantly outweighed by the volume of soil that was physically observed to have been lost or gained by the site through erosion. For example, the willow fence at Site 26 has an estimated maximum holding capacity of two cubic meters, given its height, width, and distance away from the base of the landslide in 2004.

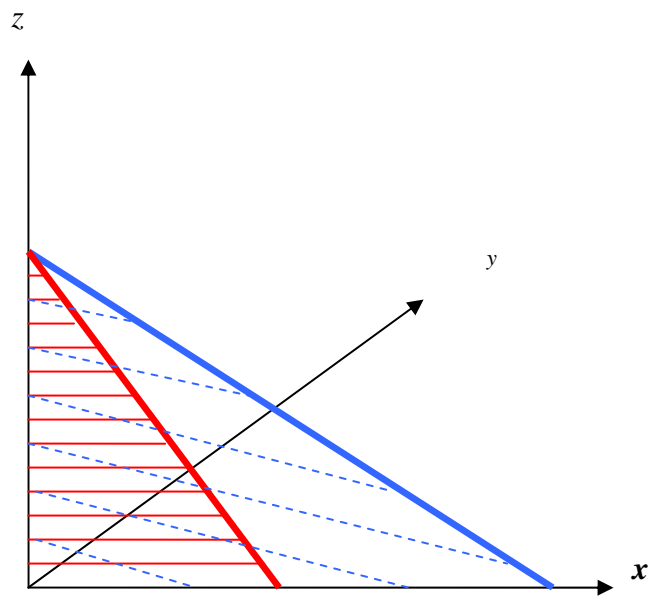
Figure 14. Relationship between hillslope volume and slope.
